Project Update June 2009

EHC Pilot Study for Oregon DEQ's Dry Cleaner Program at a Former Dry Cleaner Site, OREGON USA
Project manager/regulatory contact: Don Hanson, Oregon Department of Environmental Quality

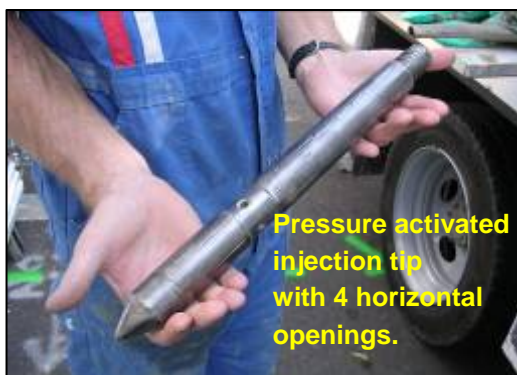
A test injection was conducted prior to full-scale implementation to evaluate the effectiveness of direct push methods in distributing EHC in the low permeability soils. A total of 450 lbs of EHC was injected from 13 to 25 ft bgs (4 discrete layers, spaced 4 ft apart) using GeoProbe's pressure activated injection tip. A high pressure pneumatic grout mixing and pumping system was used to mix and pump the EHC to the injection tip. Six soil cores were obtained around the injection point (from 0.5 to 5 ft from the injection point) to assess the radius of influence of the injection (**Figure 1**). EHC fractures were found at the farthest sampling points indicating that the radius of influence was up to at least 5 ft. **Figure 2, 3, 4** and **5** show some of the EHC bands or fractures observed in the soil cores.

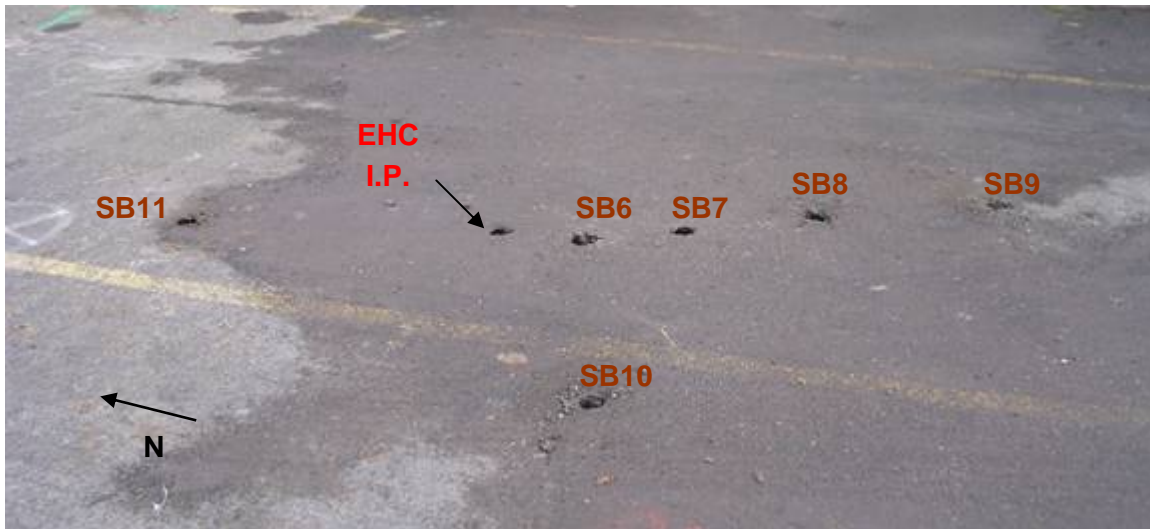
Figure 1: Soil sampling locations around EHC injection point.

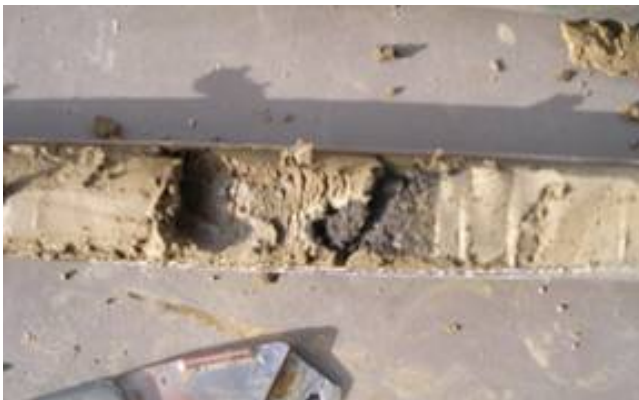
Figure 2: EHC fracture at 17.5 ft bgs (SB6).

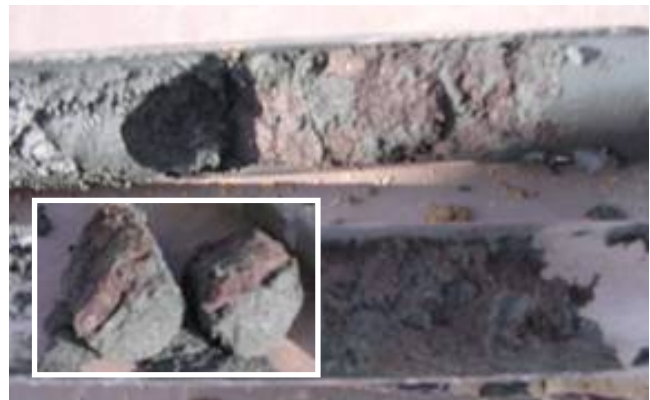
Figure 3: Vertical EHC fracture at 26.8 ft bgs (SB6).

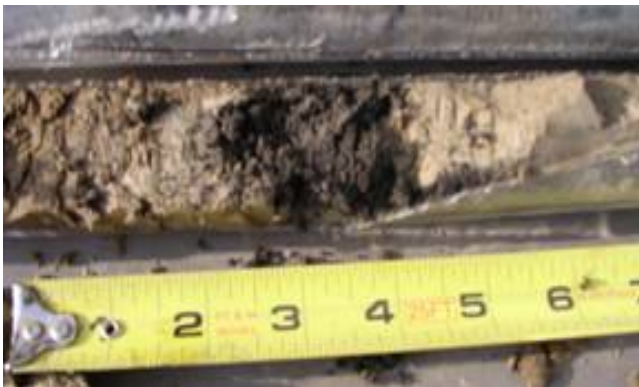
Figure 4: EHC fracture at 17 ft bgs (SB7).

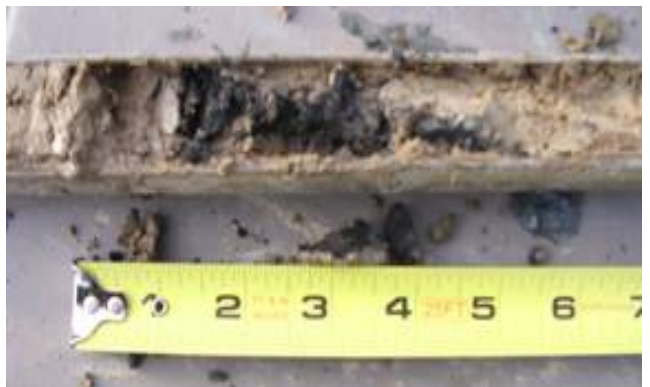
Figure 5: Vertical EHC fracture at 17 ft bgs (SB9).

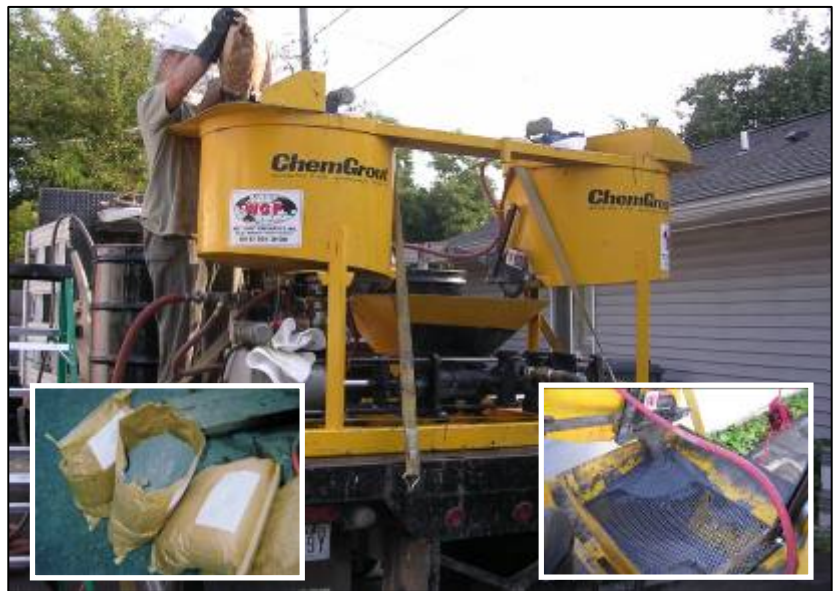
Figure 6: Chem Grout's Mixing Unit CG-500.

In August 2006, a total of 10,250 lbs of EHC was injected into an area measuring approximately 825 ft² x 20 ft deep (from 10 to 30 ft bgs), which resulted in an average application rate of 0.6% to soil mass. The EHC was supplied as a dry powder in 50-lb bags and mixed with water on site into slurry containing about 29% solids (Figure 6). Using conventional direct push technology, the EHC slurry was injected at 3 to 6 GPM at a pressure of approximately 200-400 psi. The depth interval targeted was from the groundwater table (ca. 10 ft bgs) to approximately 30 ft bgs, where a less permeable layer was encountered. The EHC was injected in discrete layers using the Geoprobe pressure-activated injection tip and high pressure grout mixing unit.

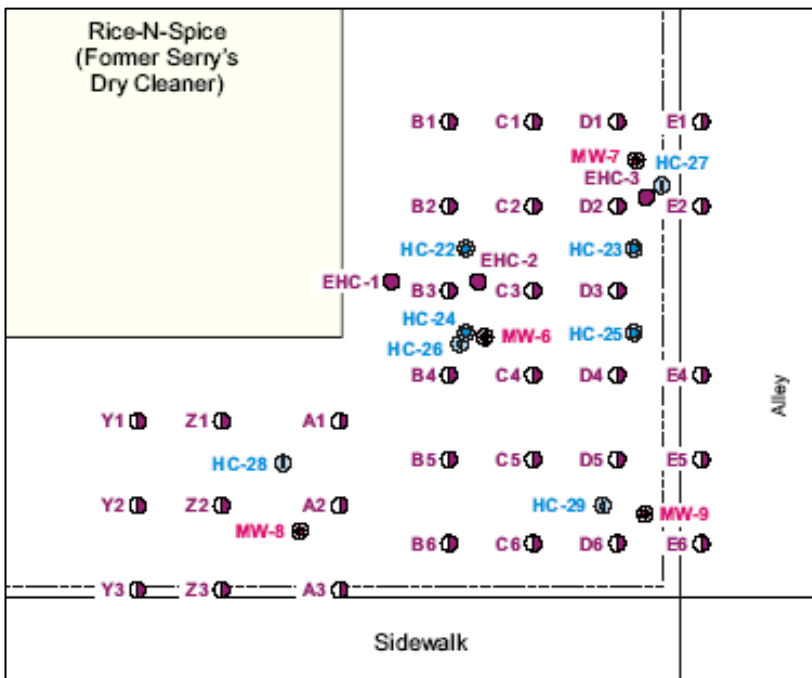
Figure 7: EHC injection locations, groundwater sampling locations, and monitoring wells.

The EHC was added to a total of 32 injection points (Figure 7), including nine additional points south of the building. The additional points were added due to issues with surfacing: it was not possible to achieve the originally planned application rate of 1% to soil mass in the tight soil formation at the targeted flow rate of approximately 5 GPM due to pressure build-up in the subsurface. The treatment area was therefore increased resulting in a lower application rate of 0.6% to soil mass within the treatment area. In addition, a relatively tight injection spacing of 5 ft was used for the EHC injections based on the results from the test injection. Approximately 18 lbs of EHC was added per vertical foot on average.

Figure 7 also shows the locations of four new monitoring wells (MW-6 to MW-9) installed in January 2007. Previous monitoring performed in February 2005 and August and September 2006 was conducted via direct push probe exploration locations (HC-22 to HC-29).

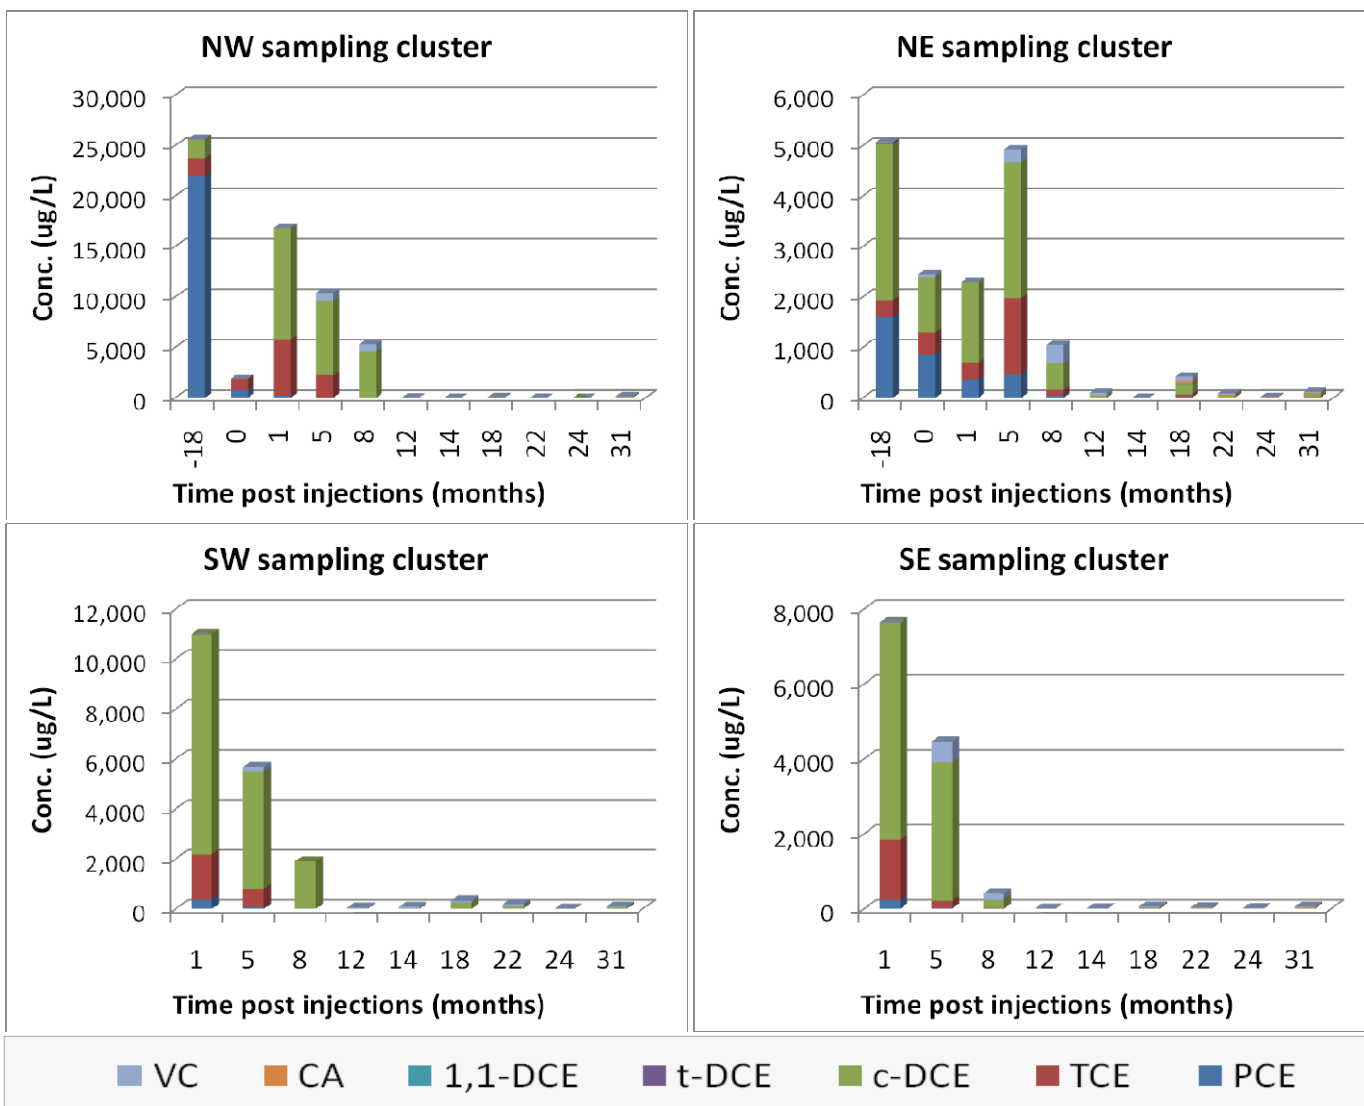
Note: The data from Feb 2005, Aug 2006, and Sep 2006 was obtained via direct push probe exploration locations. Subsequent monitoring was conducted via groundwater monitoring wells installed close to each of the previous direct push sampling clusters.

Figure 8: Influence of EHC injections on PCE and daughter products in groundwater.

Following injection of EHC into the suspected source area, PCE was decreased to below the detection limit of 1 ug/L and total CVOCs decreased from a maximum of 25,606 ug/L to below 100 ug/L at all locations within 12 months (Figure 8). The PCE degradation resulted in an initial build-up of TCE, DCE (primarily cis-DCE) and VC, indicating that sequential dehalogenation was occurring (biological pathway). However, conversion rates were less than Stoichiometric and concentrations of all constituents appeared to decrease simultaneously, suggesting that abiotic treatment mechanisms also occurred at significant rates. Observed generation of VC was limited, indicating that abiotic beta-elimination was a primary pathway for cis-DCE degradation. A smaller concentration of chloroethane (CA) was also observed (maximum concentration of 44 ug/L measured in February 2008 – 18-month data), suggesting that hydrogenation of VC might be occurring.

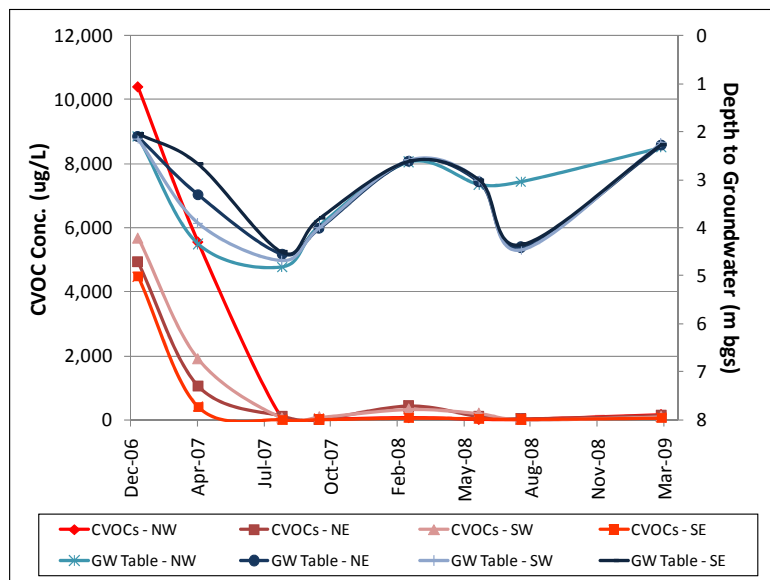
Figure 9: Total CVOCs and depth to groundwater.

Historically, CVOC concentrations in groundwater fluctuate heavily with the seasons in the study area. **Figure 9** shows the groundwater elevation and total CVOCs concentrations measured since the well installations. Transient rebound was observed during the rainy season (18-month data), presumably due to the introduction of CVOCs from the smear zone as a result of a 6 to 7 ft (1.8 to 2.1 m) increase in the groundwater table. While the groundwater table remained high through June 2008 (22-month data), total CVOC concentrations decreased, suggesting continued treatment via resident, active EHC. By August 2008 (dry season), PCE and TCE both decreased to below the detection limit of 1 ppb at all locations. The rebound observed during the following wet season (March 2009) was much smaller than the previous year, suggesting that treatment of the smear zone is being achieved as desorption is promoted.

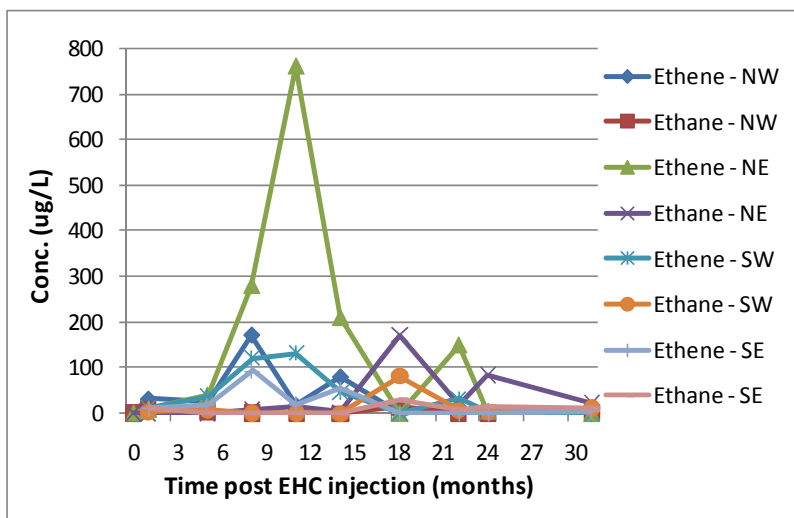
Figure 10: Degradation end products.

Degradation end products. An increase in ethene and ethane levels confirms that complete degradation is occurring (Figure 10); ethene levels of up to 760 ug/L were measured in July 2007 (11-month data) which

constitutes an increase of 96% compared with the maximum concentrations measured in August 2006. As total dissolved concentrations of chlorinated ethenes decreased within the treatment zone, the concentration of dissolved gases has also decreased. However, concentrations of ethane remain above baseline levels, suggesting that a smaller concentration of sorbed CVOCs remain and that degradation is still ongoing. A spike in ethane concentrations were observed at the NE and SW monitoring wells during the rainy season (18-month data), as CVOCs sorbed to the smear zone entered the system and became available for degradation.

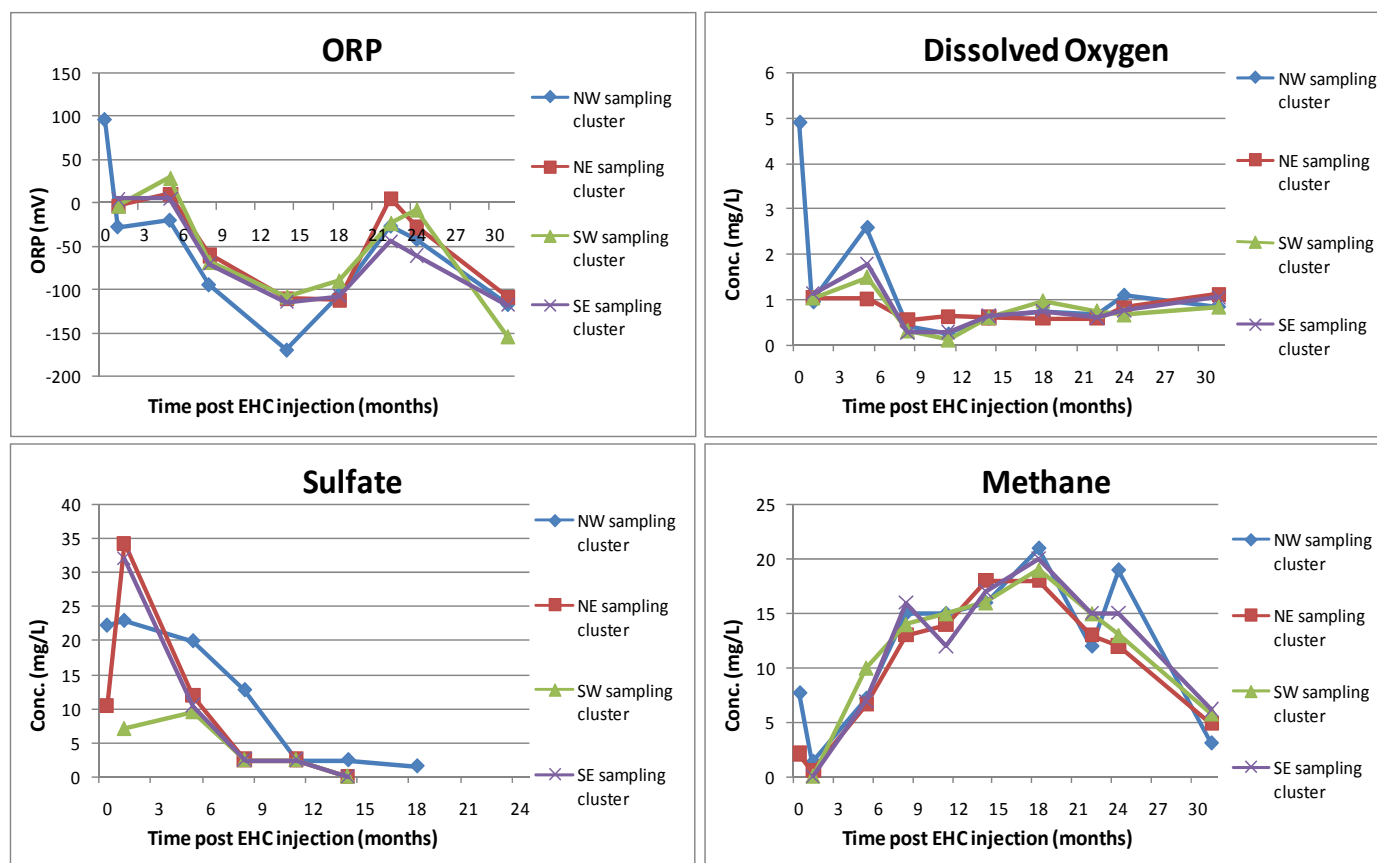
Figure 11: EHC effect on redox indicator parameters measured within treatment area.

Redox indicator parameters: Following the EHC injections, the oxidation-reduction potential (ORP) decreased within the injection zone. Sulfate concentrations decreased from a baseline concentration of 7 to 34 mg/L to below the detection limit of 0.1 mg/L, suggesting that sulfate reducing conditions was established within the injection zone. Furthermore, an increase in methane suggests methanogenic conditions and an excess amount of dissolved carbon. As dissolved carbon concentrations declined over time, ORP has increased. However, methane levels remain high, suggesting that reducing conditions are maintained within the treatment zone.
